HISTORIC STRUCTURES REPORT
ARCHITECTURAL DATA SECTION

February 1986

JACOB RIIS BATHHOUSE EXTERIOR
JACOB RIIS PARK HISTORIC DISTRICT
GATEWAY NATIONAL RECREATION AREA
NEW JERSEY/NEW YORK

by
John B. Marsh
and
Sally Small

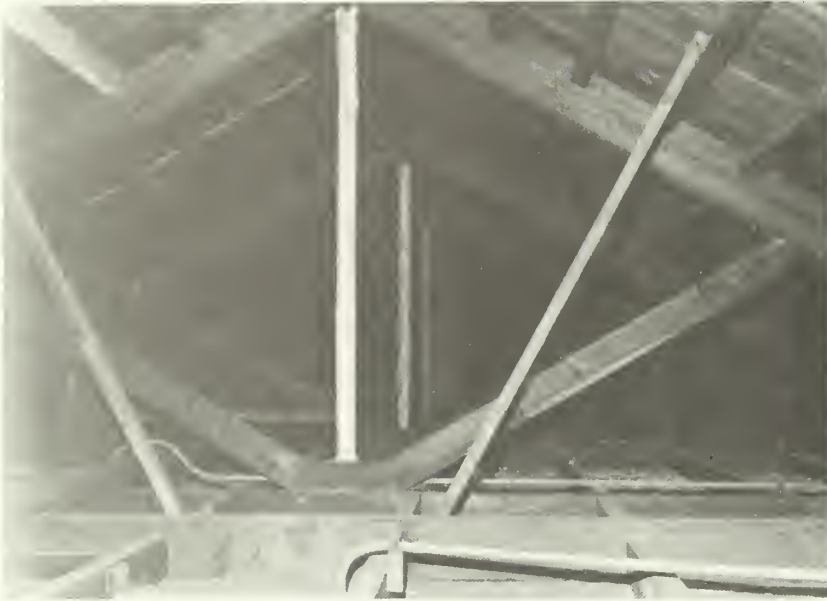
Figure 7: Roof framing at Beach Pavilion. Note wood trusses with steel central post. Ceiling framing below.
NPS photo October 1985.

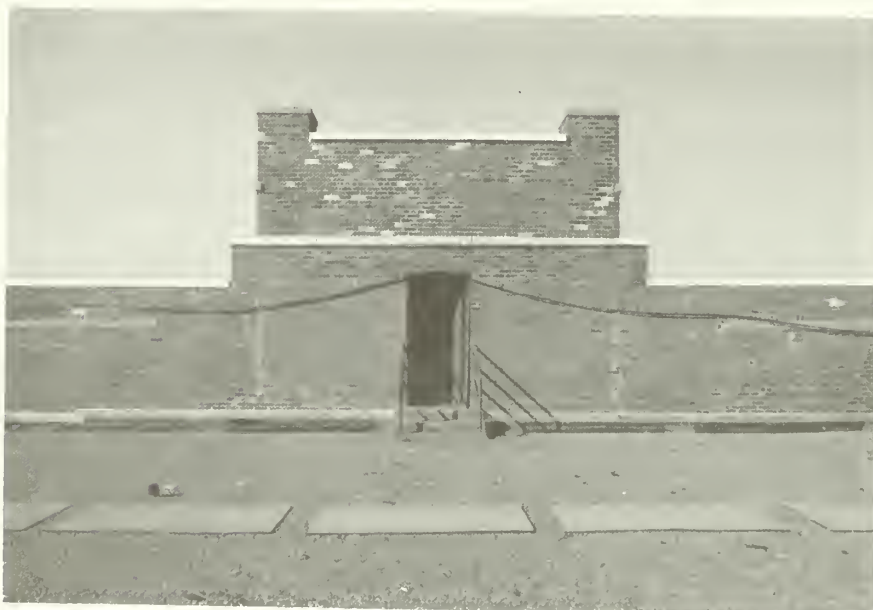
Figure 12: Built-up roof in front of Utility Penthouse. NPS photo, October 1985.

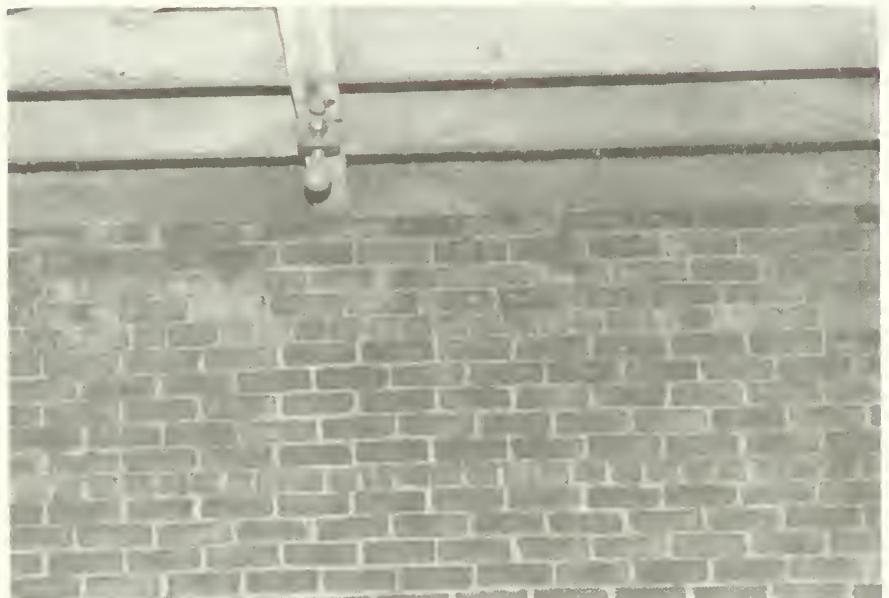
Figure 18: Unbraded brickwork at interior of "Shed A." No sandblasting occurred here and remnants of older paint remain.
NPS photo, October 1985.

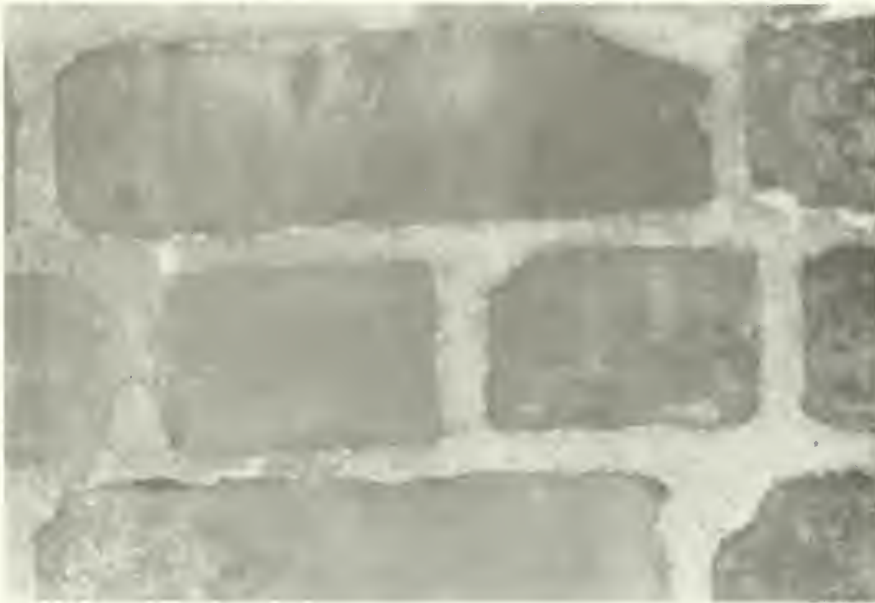
Figure 19: Closeup of unabraded wall beneath "Shed A." Note paint at mortar joints and on brickwork. NPS photo, October 1985.

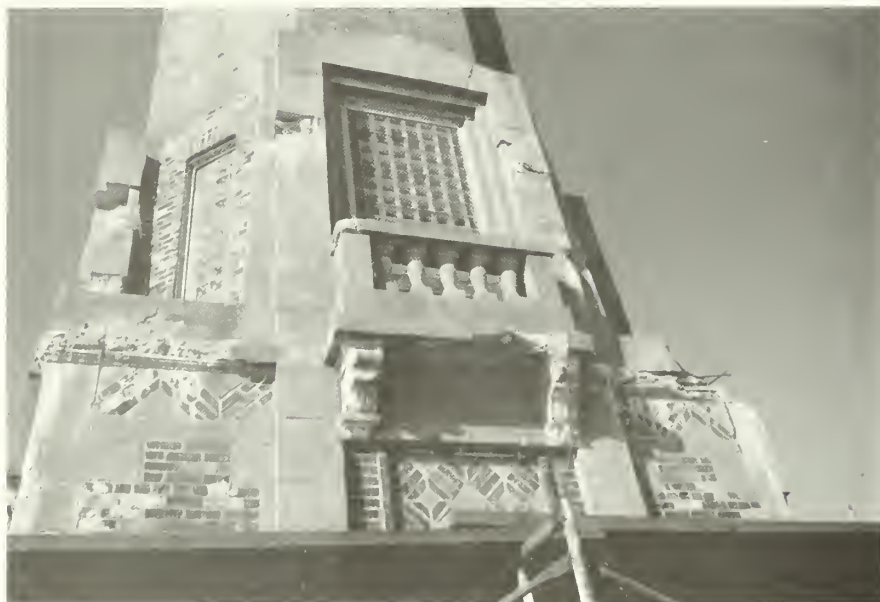
Figure 28: Deteriorating walls and decorative features at towers. Note also solid glass block windows.
NPS photo, October 1985.

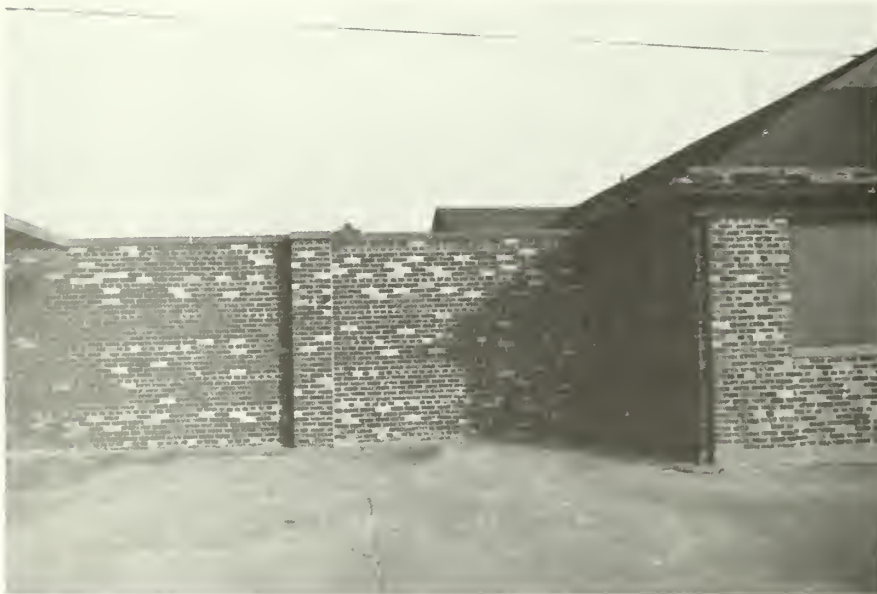
This wall (Fig. 32) has similar problems but they are substantially greater.

Figure 32: East Screen Wall: Walls conditions similar to those of West Screen Wall.
NPS photo, October 1985.

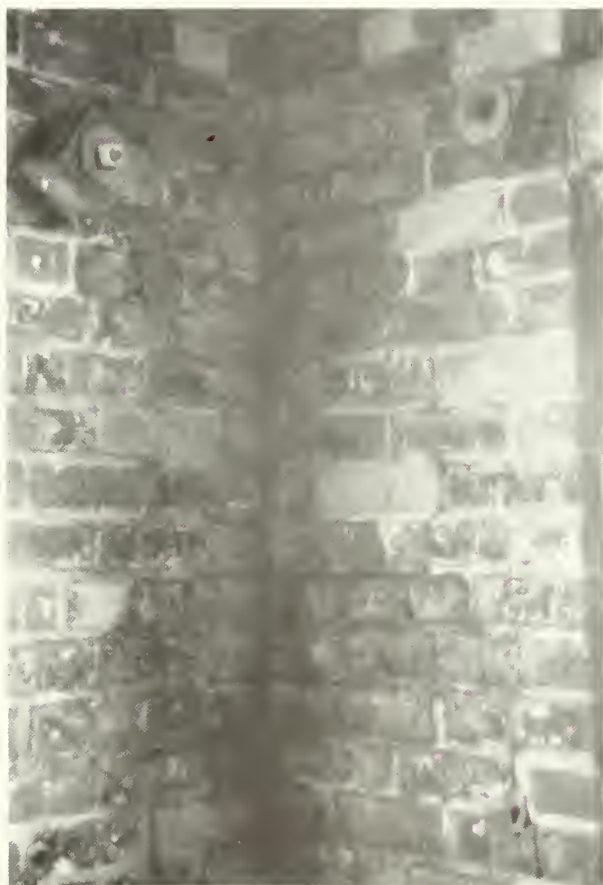
Figure 38: Typical wall conditions, with bolts at interior of Entrance Pavilion arcade. NPS photograph, 1985.

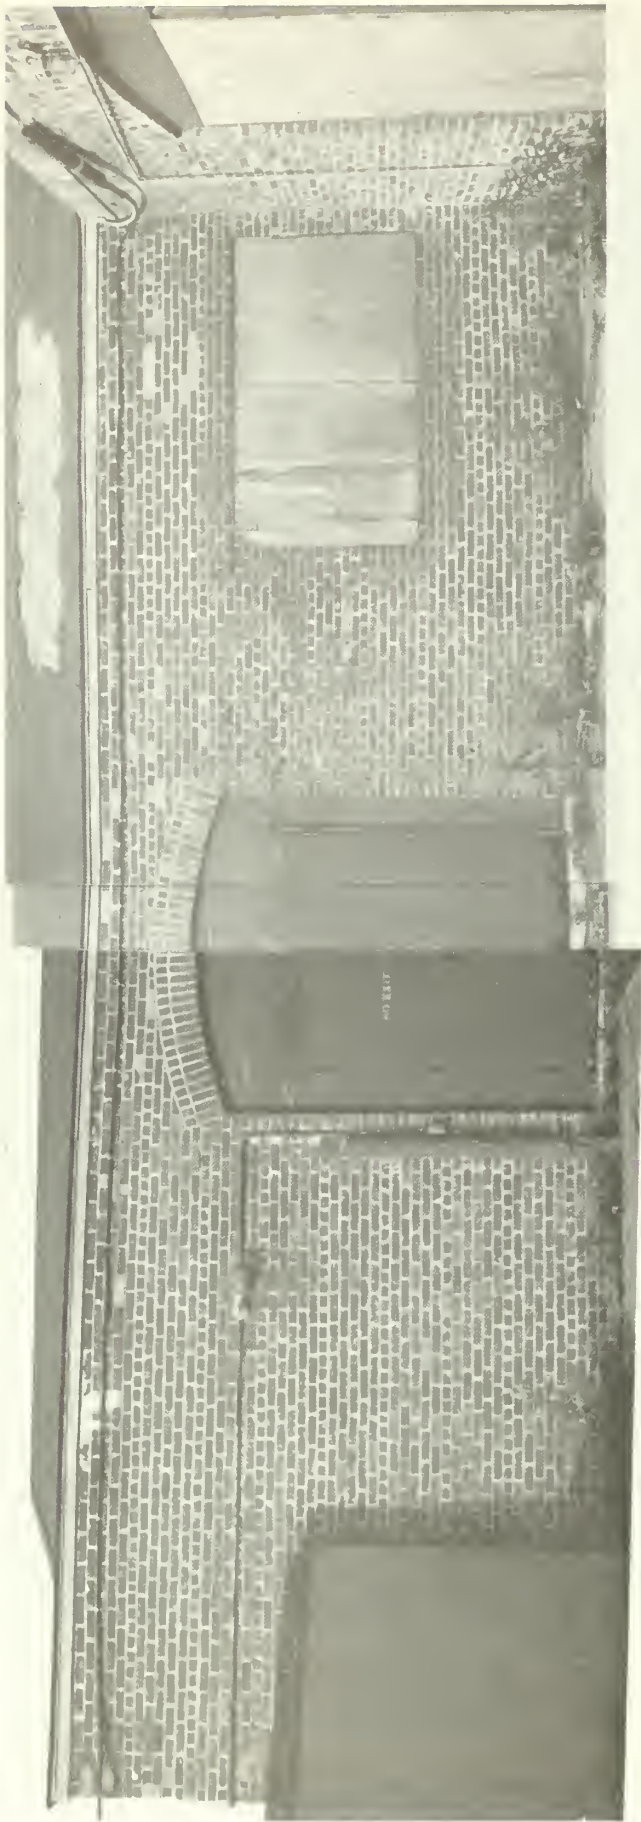
The east and west walls of the Entrance Pavilion, south of the screen wall, are in good condition. A small area of efflorescence occurs just below the coping on the east wall (Fig. 46). The west wall has approximately 28 linear feet of rusted metal coping in need of replacement (Fig. 47). Concrete block walls that enclose a central courtyard abut both walls.

Figure 46: East side of Entrance Pavilion.
NPS photo, 1985.

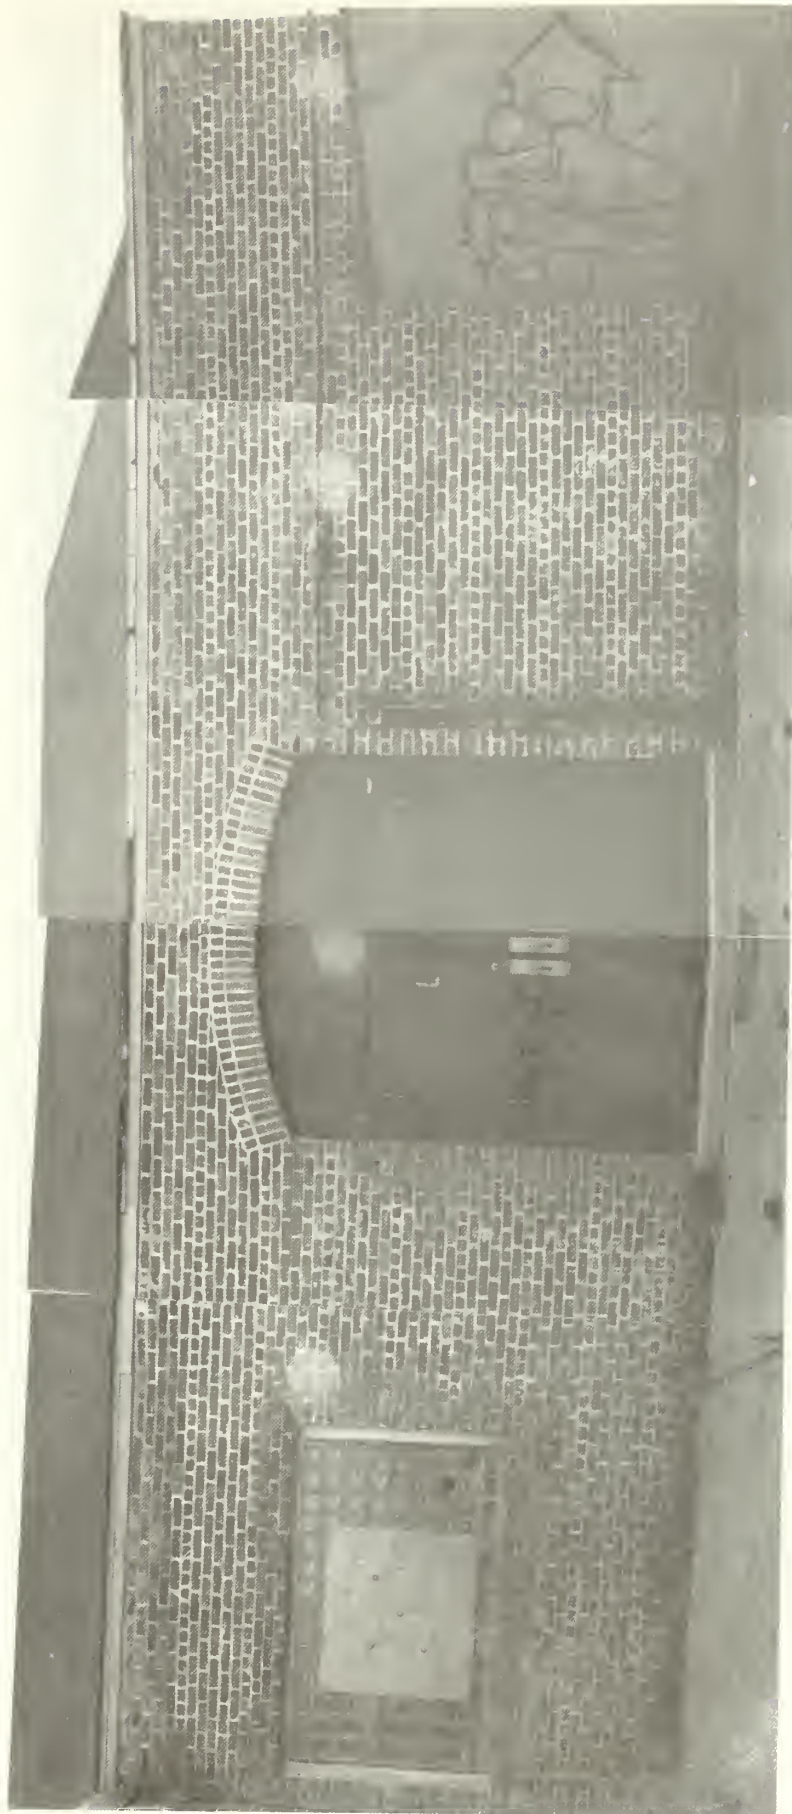
Figure 47: West side of Entrance Pavilion.
NPS photo, 1985.

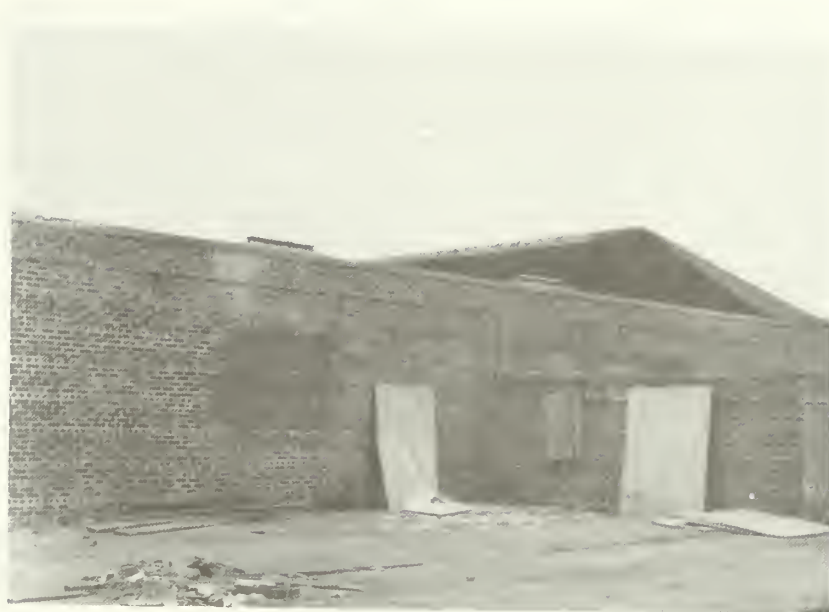
The south wall of the Entrance Pavilion is in fair condition (Fig. 49). Sixteen feet of coping is deteriorated and needs replacement. Efflorescence occurs on the wall under these deteriorated sections of coping. In the center of the wall are ghosts of two doorways that were bricked in during the 1937 modifications.⁴³ Between these two doorways, a short section of brick wall abuts the south wall. A ghost on the south wall indicates the abutting wall once was higher.

Figure 49: South wall of Entrance Pavilion.
NPS photo, 1985.

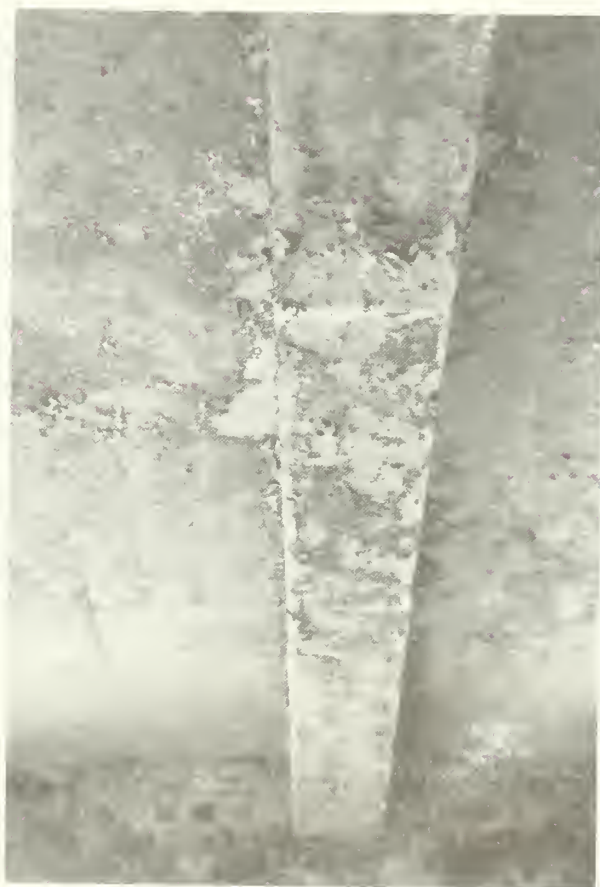
The majority of the beams are nine inches wide, while beams E, F, K and L are 16 inches wide and are supported on cast stone brackets decorated with acanthus leaves. For the most part, the beams are in fair to good condition. Peeling paint is a common problem, along with dark stains from the reinforcement bars. Beams D and I each have three cracks running east and west. These cracks appear to be structural in nature, due to the beam's inability to withstand tensile forces in the bottom of the beam. The paint at Beam D and L is peeling severely and there are heavy efflorescence deposits at each crack (Fig. 50). The decorative bracket at the south end of Beam L is covered with a heavy deposit of efflorescence, while the north bracket is spalled and has some efflorescence. Efflorescence also occurs at the joint between the beam and south bracket at beams E and F. The ceiling of the arcade is a flat concrete slab, with bays FG, GH, HI, IJ and JK divided into three areas by wood beams running east and west. Each wood beam is decorated with three rosettes. The ceiling at bays EF and KL is vaulted and is of coffered plaster. The concrete ceiling is generally in good condition with small areas of peeling paint. Bays FG, JK, and NO have significant cracks. The coffered ceiling at Bay KL is in good condition, (Fig. 51) while the coffered ceiling at Bay EF is in poor condition. The plaster at ceiling EF is loose, missing, and water damaged and has efflorescence deposits. This section of ceiling will require extensive repairs and replacement.

Figure 50: Beam D of
the Entrance Pavilion.
NPS photo, 1985.

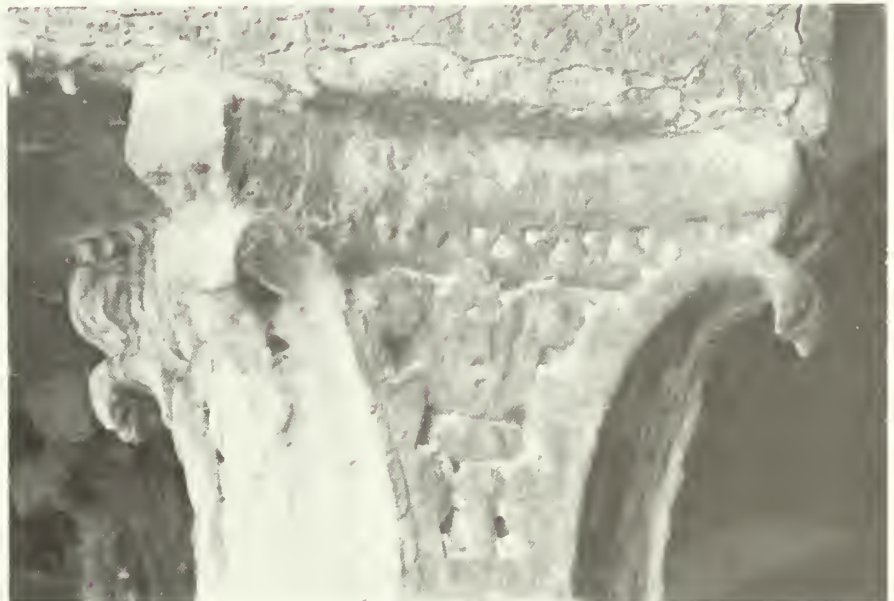
Figure 54: Typical column capital with efflorescence.
NPS photo, 1985.

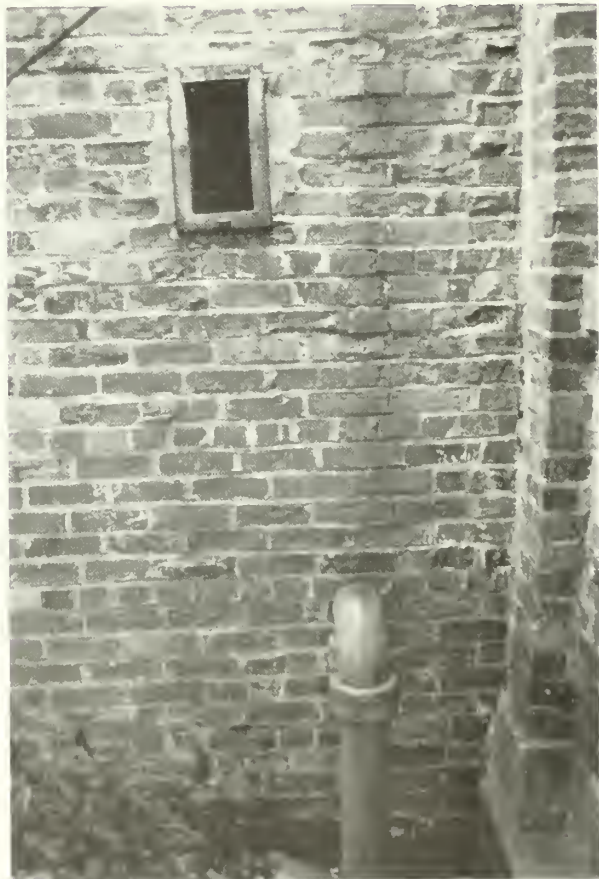
Set into the far east and west bays, adjacent to the end wings, are rusted metal frames for small doors opening into the meter rooms. Presumably, these doors allowed water meters to be read from the exterior of the building. The doors themselves no longer exist (Fig. 56) and should be replaced.

Figure 56: Door into meter room, West Screen Wall.
NPS photo, 1985.

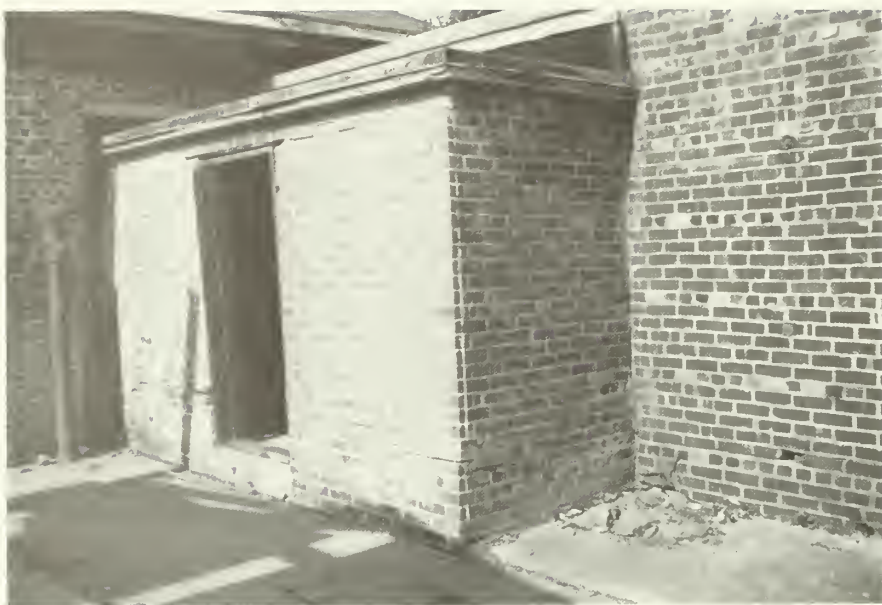
move upward. There is also a severe horizontal crack several courses above the floor, starting to the west of the door and wrapping around the meter room to the east and north. The entire meter room above this crack has rotated counterclockwise about a half inch (Fig. 59).

Figure 59: Meter room at West Screen Wall.
NPS photo, 1985.

Meter Rooms intersecting the Screen Walls and Wings at the north elevation should also be examined, due to their movement which appears to be caused by several factors (expansion, water damage).

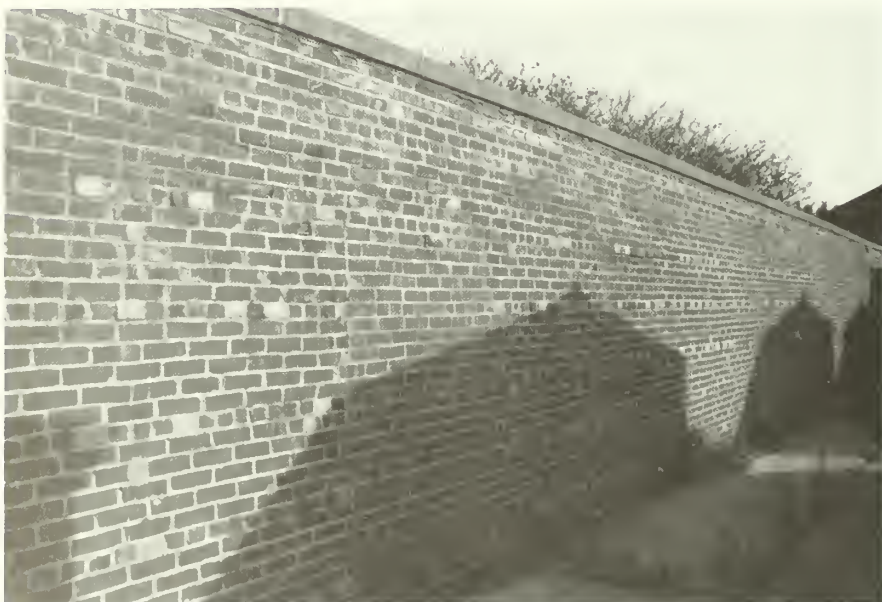
Over all, the East Screen Wall is in fair condition, with areas of spalled brick, individual spalled bricks, and cracks throughout the length of the wall. The cast stone coping appears to be in good condition, with no visible spalling or crumbling. In the ninth bay east from the Entrance Pavilion, there is a large area patched in red brick, as if there once had been a door in that location (Fig. 60).

Figure 60: South face of East Screen Wall, showing
brick infill at bay 9.
NPS photo, 1985.

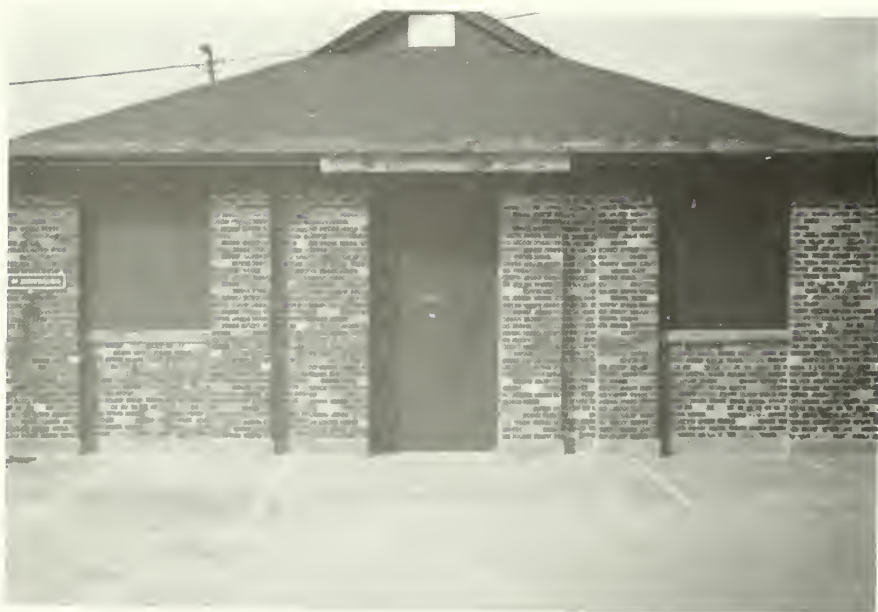
The exterior and interior of the south facade is in good condition (Fig. 64).

Figure 64: South end of West Wing.
NPS photo, 1985.

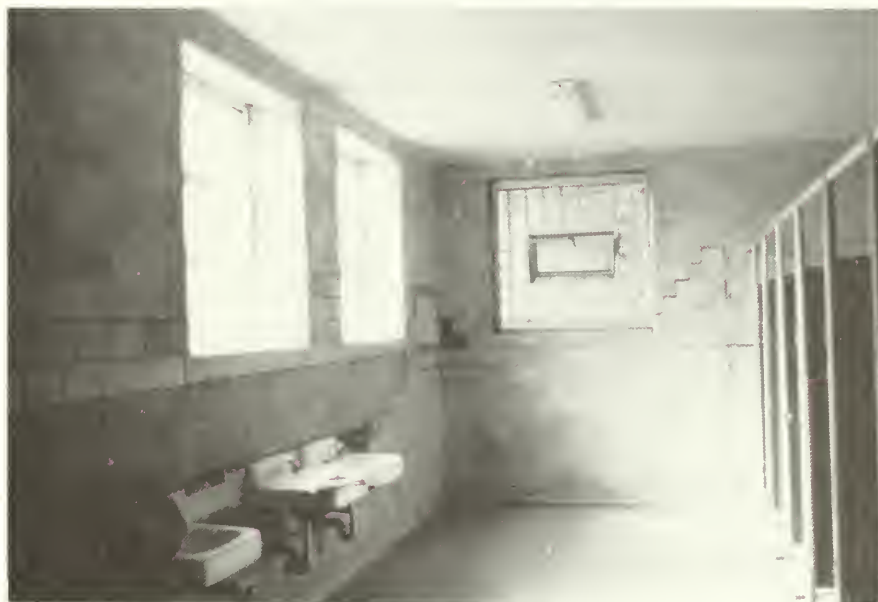
The west facade is also in good condition, although the wall bows out to the west slightly below window 506. A large power pole is attached to the wall between windows 509 and 510 (Fig. 65). The interior face of the west wall has numerous problems at the toilet rooms. In the men's toilet horizontal cracks occur a course above and below the window sill, and the wall below and adjacent to window 507 bows inward slightly. Similar cracks occur in the west wall of the women's toilet room. Three courses of glazed structural tile immediately under windows 503 and 504 and extending south to Door 503 have been replaced at some time with concrete block and brick (Fig. 66). The interior finishes around windows 509, 510 and 511 are deteriorating due to water leaking in from the gutter (Fig. 67).

Figure 66: Interior of women's toilet room, West Wing, looking north. NPS photo, 1985.

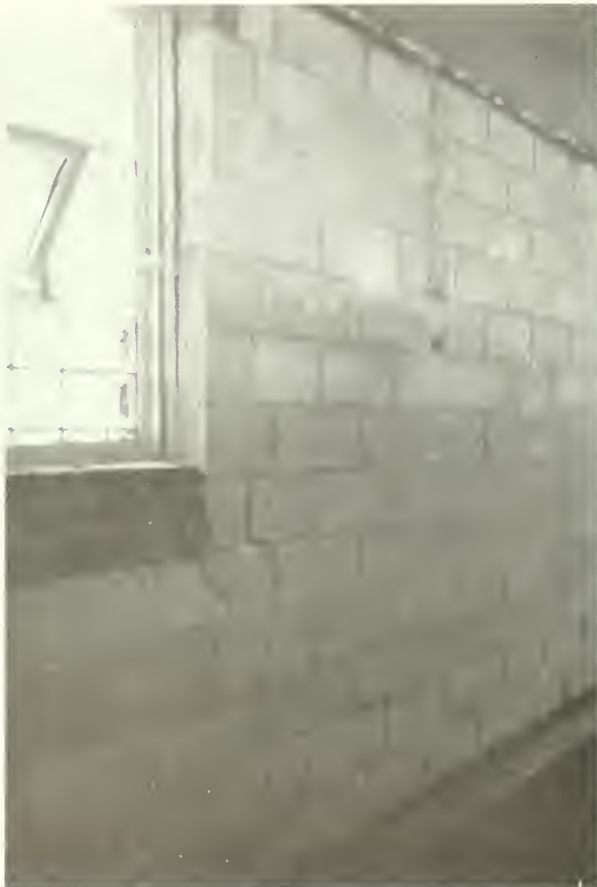
On the interior, the wall has been rebuilt from the north wall to Window 528, using concrete block and brick in place of the glazed hollow tile. The concrete block has cracked vertically at the screen wall, and the top of this portion of wall is bowed in about an inch (Fig. 68).

Figure 68: Rebuilt east wall, women's toilet room, West Wing. NPS photo, 1985.

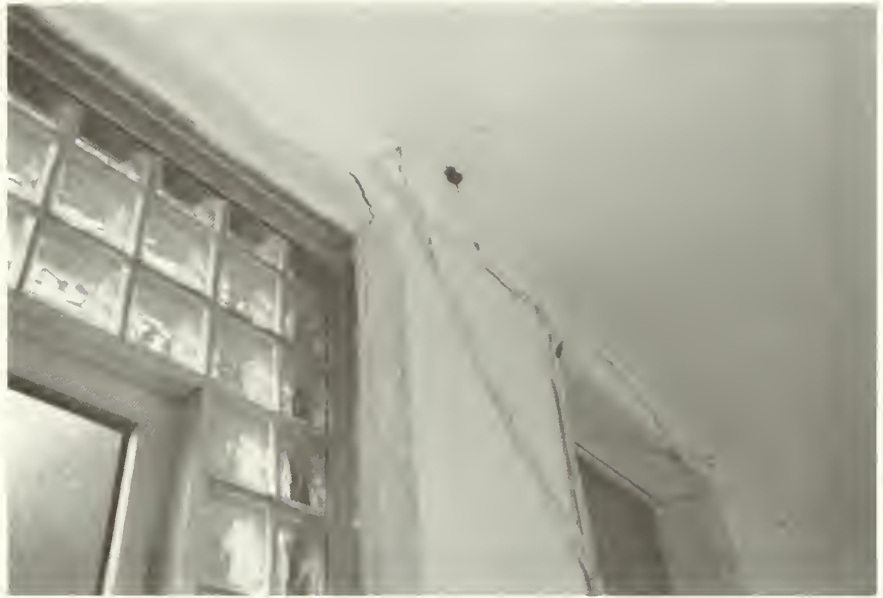
At windows 517 and 518 the interior wall is severely bowed, with a large crack in the pier between the windows (Figs. 69 and 70). The gutter leaks profusely at this point with the water destroying the plaster ceiling and wall finishes. Cracks from differential settlement occur at the intersections of the interior walls and the east all.⁵⁹

Figure 69: East wall bulging out, Windows 517 and 518, West Wing.
NPS photo, 1985.

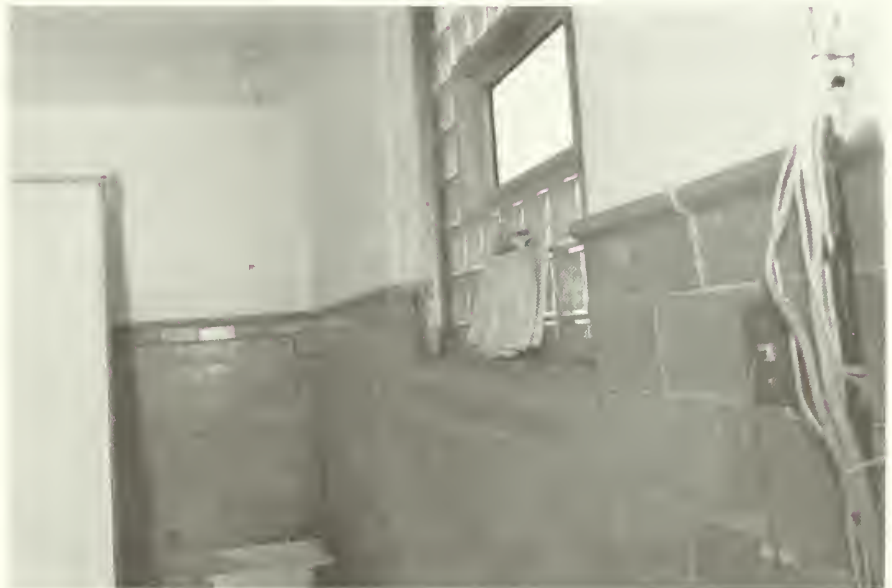
Figure 70: Bow in east wall, Window 518, West Wing.
NPS photo, 1985.

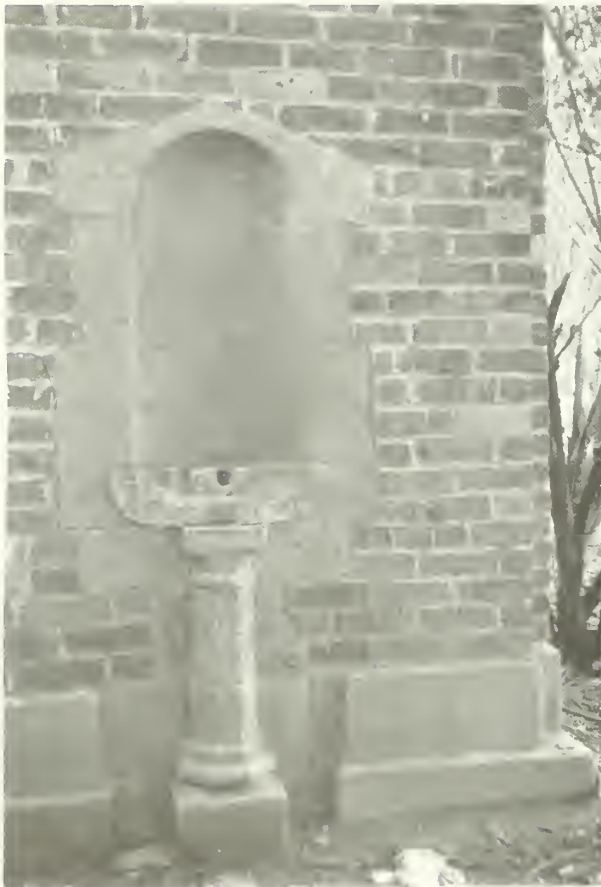
The only decorative feature at the West Wing is a cast stone drinking fountain at the north end of the east facade. The fountain consists of a cast stone bowl on a cast stone pedestal, set into a cast stone niche. The fountain no longer works, with the bowl broken off at the wall and all the hardware missing (Fig. 72).

Figure 72: Drinking
fountain at West Wing.
NPS photo, 1985.

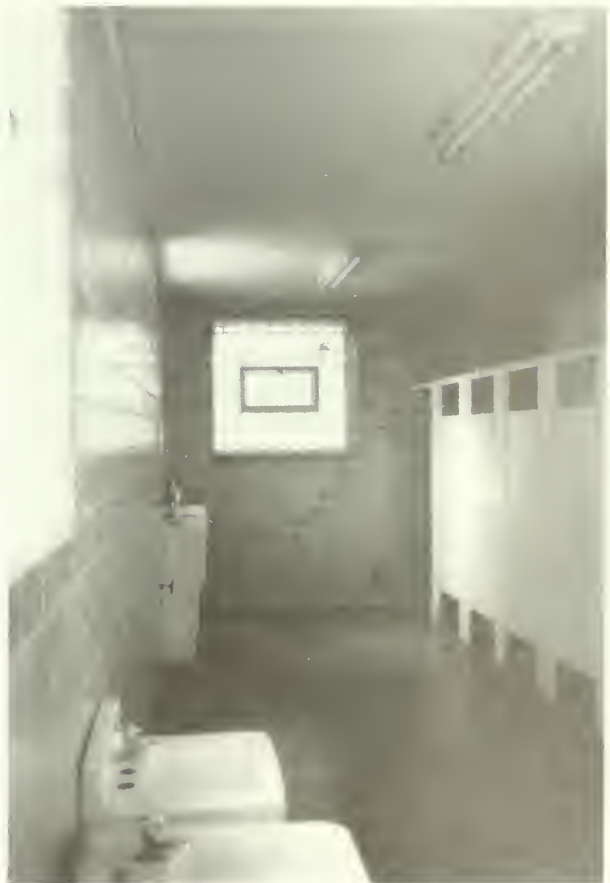
stair-steps up to about three feet below the ceiling where it continues horizontally (Fig. 76).

Figure 76: Men's toilet room, East Wing, looking north, showing bow in west wall.
NPS photo, 1985.

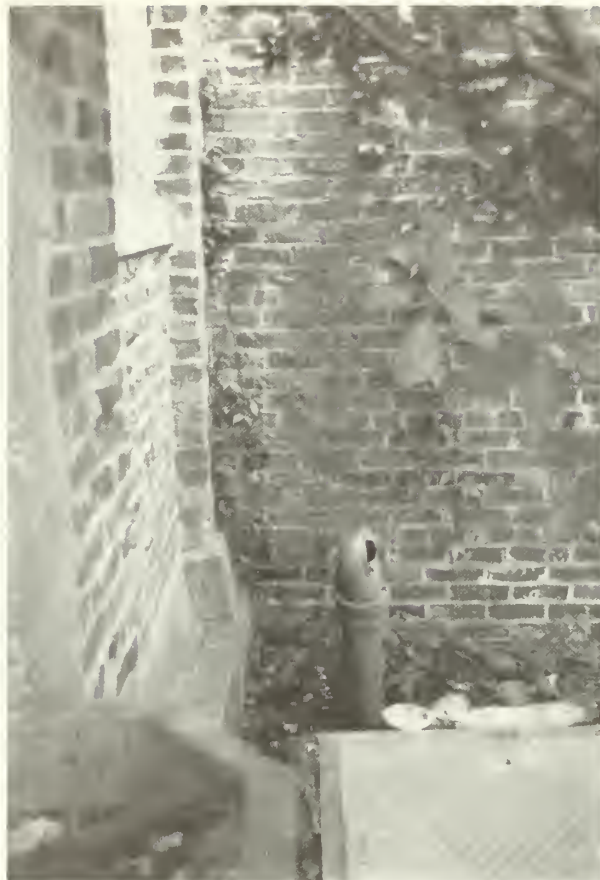
The west wall of the East Wing has a number of significant structural cracks in it. The worst area is where the North Screen Wall hits the East Wing. There is a vertical crack in the exterior wall under the window to the north of the screen wall, with the bottom of the wall shifted slightly to the west (Fig. 77). To the south of the North Screen Wall, a horizontal crack occurs approximately halfway up the wall and extends from inside the meter house, south to the next window. Another

Figure 77: Wall bulging out under Window 631, East Wing.
NPS photo, 1985.

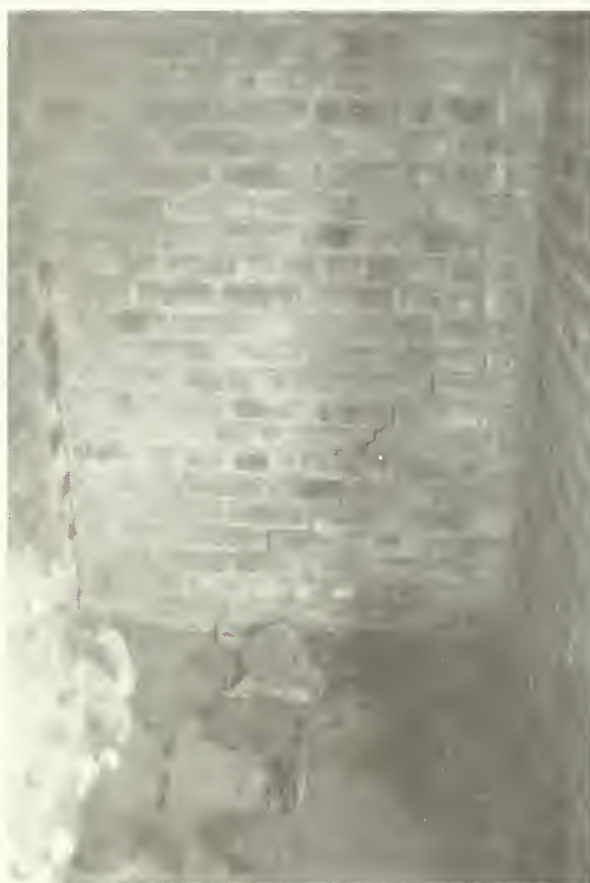
lower horizontal crack occurs inside the meter house, stairstepping up toward the south (Fig. 78). The wall below both of these cracks bows outward to the west. On the interior at this same point, the hollow clay the portion of the wall bows inward to the east, accompanied by horizontal and stair-stepping cracks in the wall (Fig. 76). A similar, though less severe condition, occurs at the juncture of the South Screen Wall, with the east wing. Horizontal cracks extend, under the adjacent window, north approximately twelve feet from the screen wall. The wall below this crack leans to the west (Fig. 79). To the south of the screen wall, three courses of brick above the adjacent window sill have shifted to the west. The interior of the wall at this location is cracked and jacked at the window sills.

Figure 78: Interior of East Meter Room showing crack in west wall of East Wing.
NPS photo, 1985.

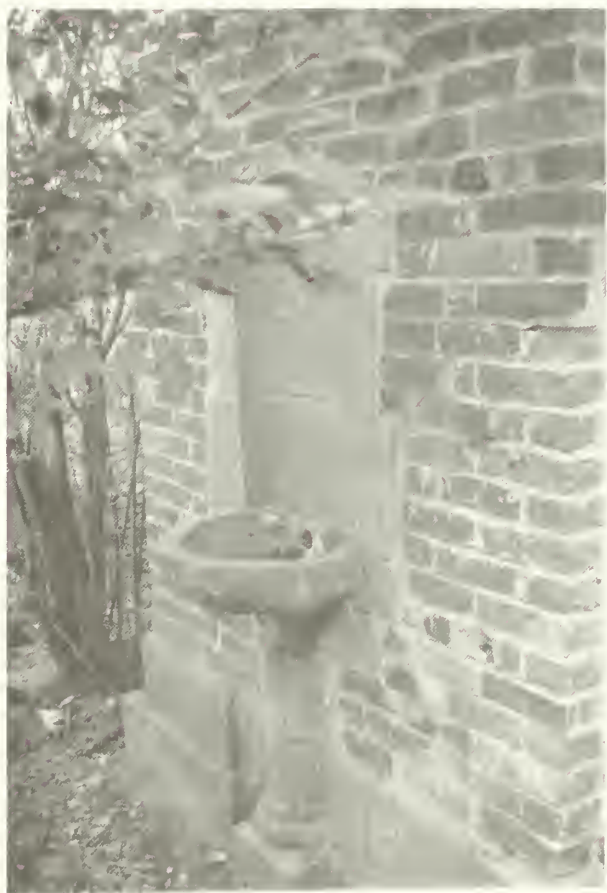
in good condition. The fountain no longer works, and all hardware is missing (Fig. 82).

Figure 82: Drinking
fountain at East Wing.
NPS photo, 1985.

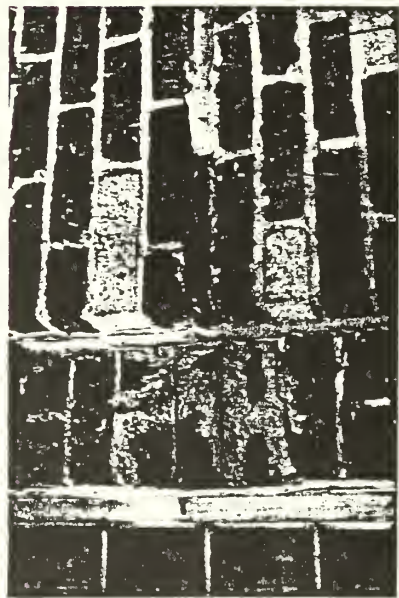
3. Detail of steel reinforcing at masonry pier,
Beach Pavilion.

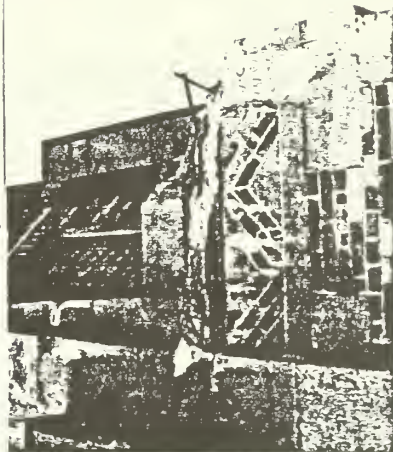
8. East tower - detail of exposed reinforcing.

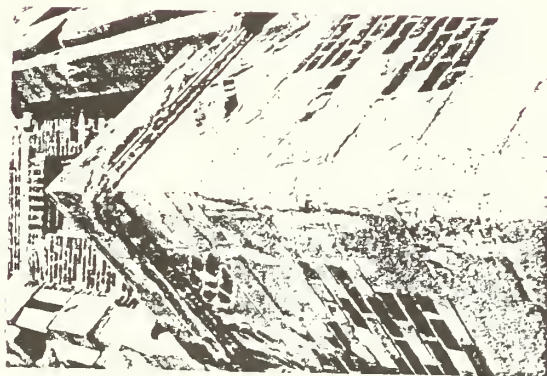
9. Detail of spalled cast stone quoins at west tower.

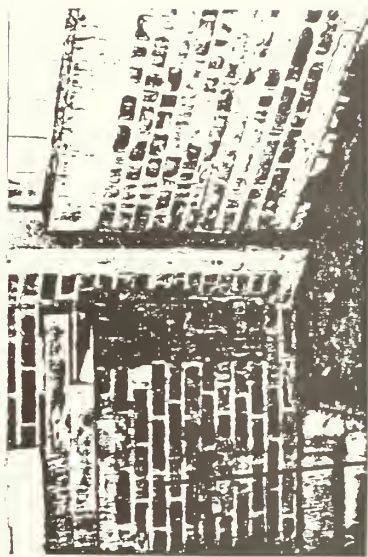
11. View of interior water damage at west tower.

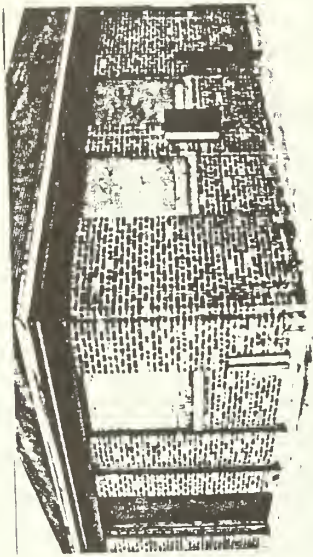
16. East wing showing typical spalling and cracking of brick walls.

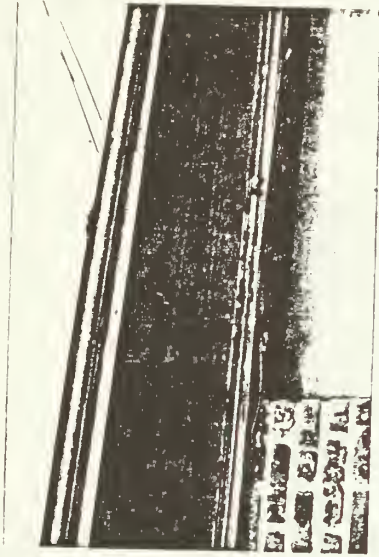
3. As a result of water infiltration at the window sills, there is cracking of some interior glazed block.
4. Wooden eaves are generally in good condition. There are some cracks and peeling paint. (See photo #18.) At eaves adjacent to the court area, it appears that the original roof drainage system leaked to the inside of the eaves causing rotting in a section approximately 40'-0" long. (See photo #19.)

18. View of typical wooden eave condition at Wings.

This condition is present in both wings and eave replacement is required.

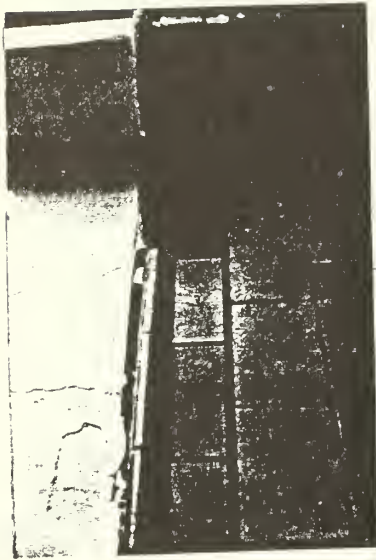
20. Settlement of partition wall at east exterior wall of West Wing.

Once water infiltration is arrested, settlement should cease, at which time repairs can be made.

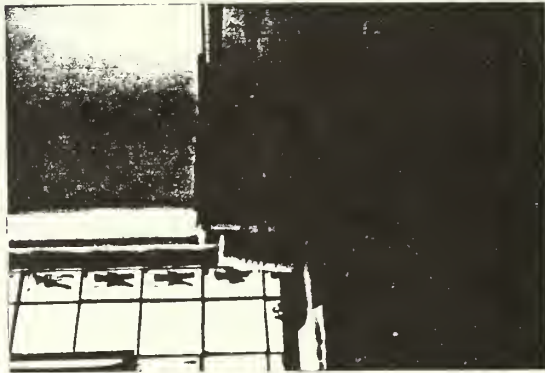
21. Settlement of east exterior wall of West Wing.

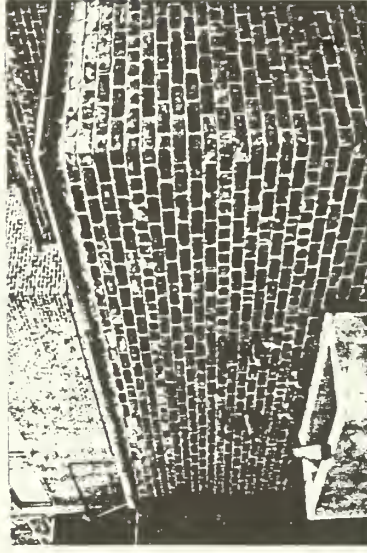
2. Free-standing masonry dressing room walls within the court are in fair condition requiring only minor repairs. (See photo #25.) Some of the glazed coping tiles are damaged and require repair or replacement as warranted.

25. Typical free standing masonry wall at courtyard.
